T-55 Engine Compressor Stator Vane Investigation

ARL-TR-2123

November 1999

Weapons and Materials Research Directorate, ARL

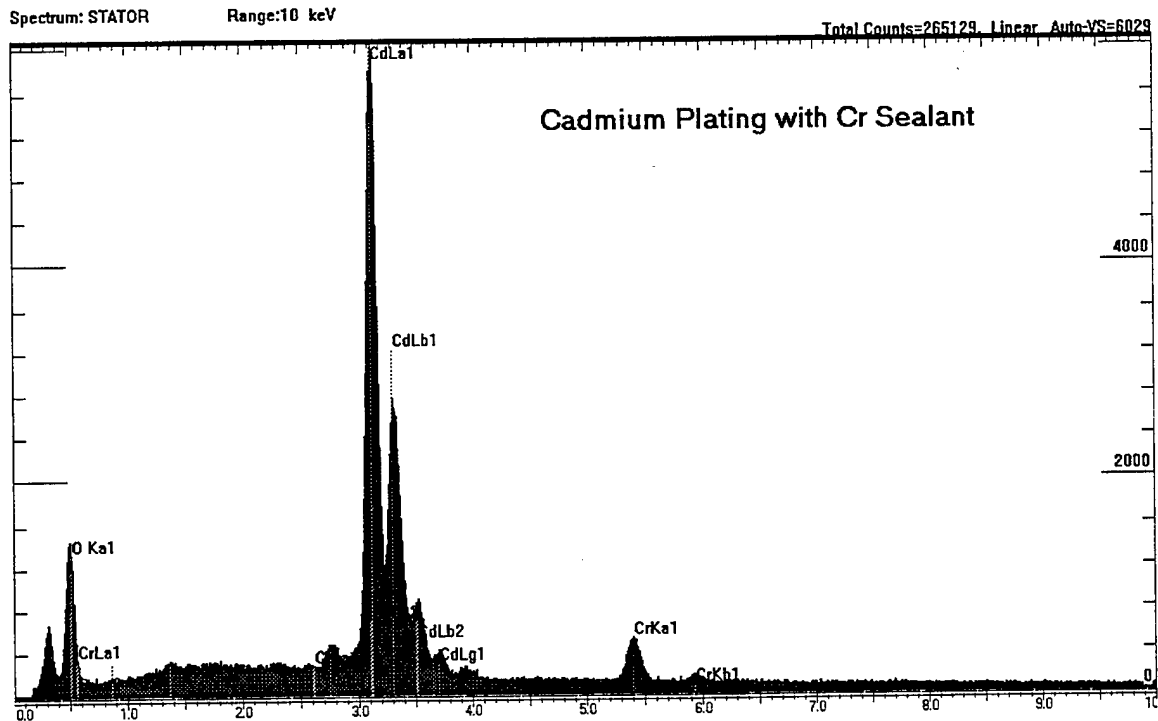
Figure 19. EDS Spectrum Showing a Detectable Cr Sealant on a Cadmium Nut.

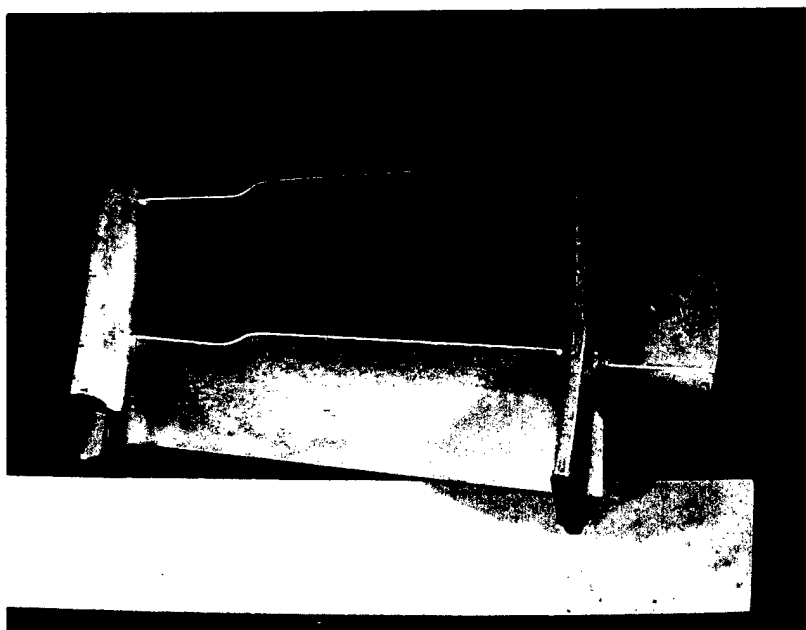
Figure 32 compares the new and old (0.42% dipped) stator sections showing the inner shroud braze area. Both stator sections show only some white cadmium oxide product. No reddish-orange corrosion of the steel is present. Figures 33–35 show that the old (2.33% dipped) stator shows no significant corrosion at all, after 24 hr salt fog exposure.

Figure 33. 2.33% Dipped Stator After 24 hr Salt Fog Exposure, Concave Side (Magnified 1.5 \times).

Figure 34. 2.33% Dipped Stator After 24 hr Salt Fog Exposure, Convex Side (Magnified 1.5×).

Figure 35. 2.33% Dipped Stator After 24 hr Salt Fog Exposure, Braze Area (Magnified 1.5×).

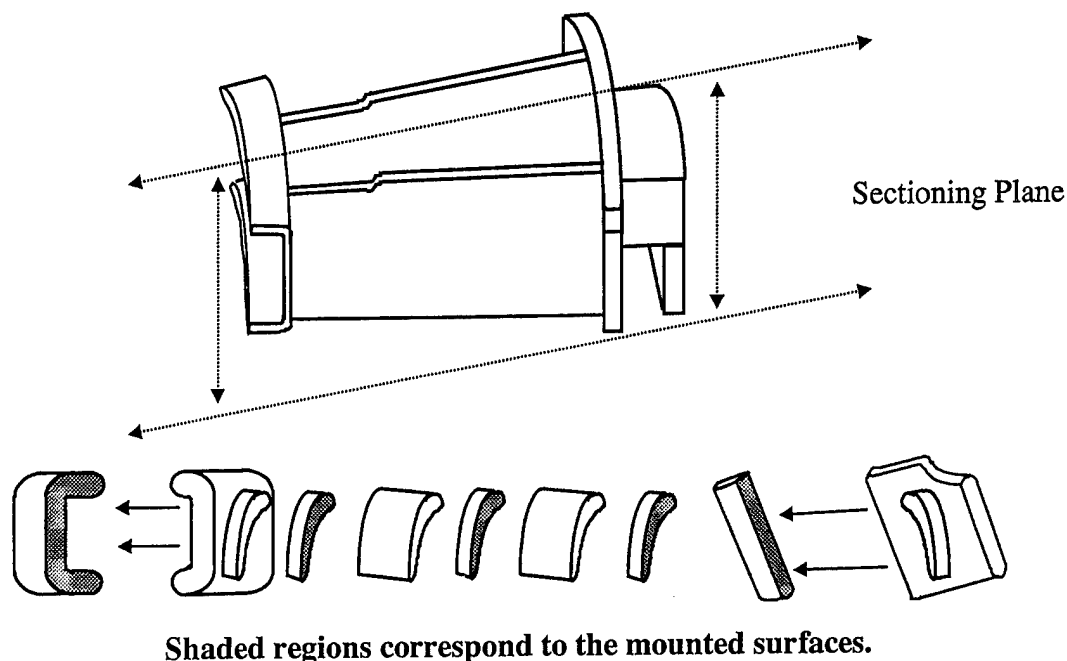
Figure 63. Diagram of Sectional Stator Vane.

5.3 Sectioning. The stator vane was sectioned after corrosion salt fog experiments to create several cross sections for cadmium coating thickness measurements. A sectioning diagram (Figure 63) is provided as follows:
